# Manhole Inspection Summary

Manhole # S45M\_\_008MH

**Location** Address: **705 s wolf st**

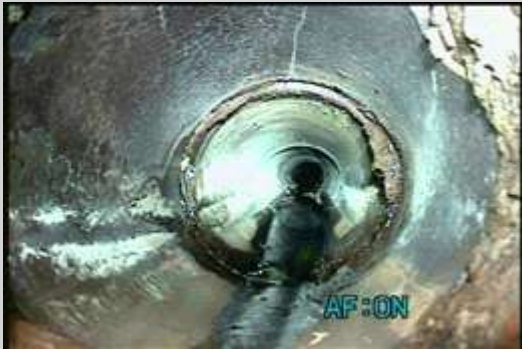
12 O'Clock Outflow

8 in. Circular Gravity Sewer  
Pipe Out @ 12 O'Clock

Invert Depth: 4.10 (ft.) Flow Characteristics: **Slow**

Infiltration: **None** Pipe Seal Cond: **Unknown**

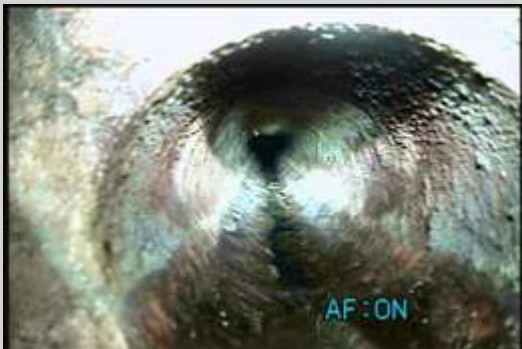
3 O'Clock Inflow

6 in. Circular Gravity Sewer  
Pipe In @ 3 O'Clock

Invert Depth: 4.00 (ft.) Flow Characteristics: **None**

Infiltration: **None** Pipe Seal Cond: **Unknown**
